SITE INVESTIGATION REPORT

YERBA BUENA ISLAND TUNNEL
SEISMIC RETROFIT PROJECT
SAN FRANCISCO COUNTY, CALIFORNIA

CALIFORNIA DEPARTMENT OF TRANSPORTATION
DISTRICT 04
DIVISION OF TOLL BRIDGE PROGRAM

APRIL 1999

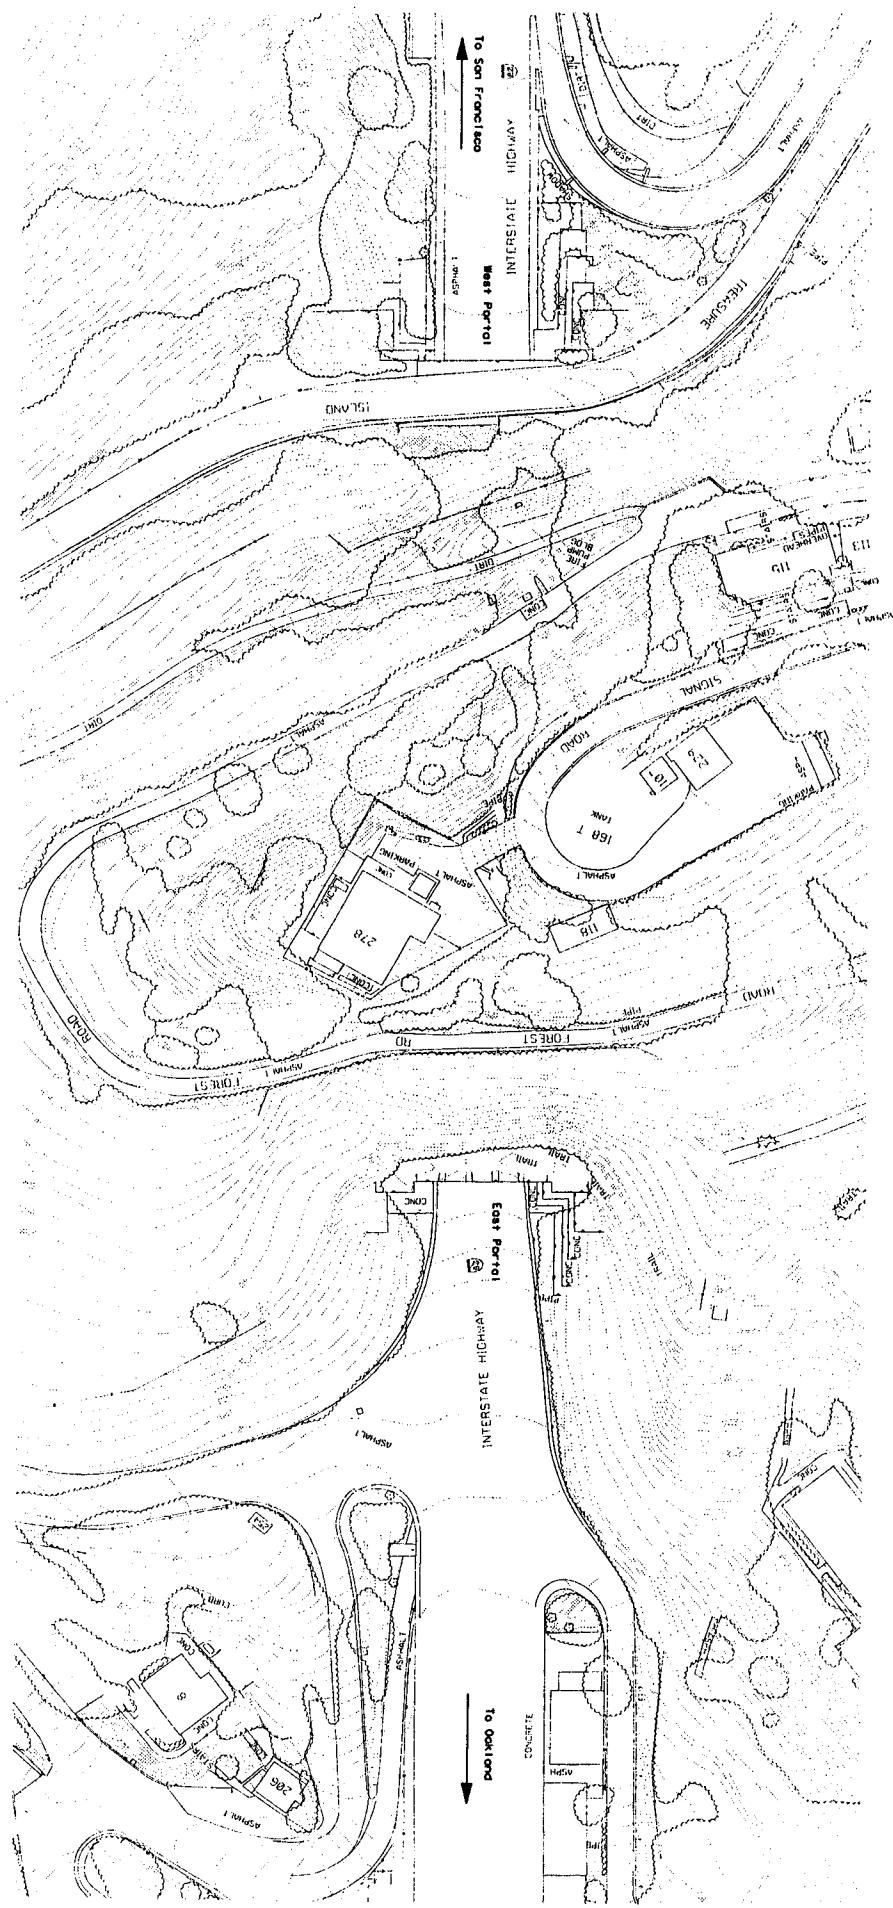
FIGURE 2
SITE PLAN

SITE PLAN

Hazardous Waste Site
Investigation of Soils
Yerba Buena Tunnel
Retrofit Project

The fieldwork for this project was performed under the direct supervision of a Caltrans assistant contract manager. The basic field procedures of this Site Investigation were to collect surficial soil samples and perform laboratory analyses to determine if soils to be excavated are impacted by aerially deposited lead from vehicle exhaust emissions and paint sandblast residue. Surficial soil samples were collected rather than depth samples because of the minor quantity of soil excavation associated with the retrofit project. The site of the investigation is located in Figure 1 – Vicinity Map and depicted in Figure 2 – Site Plan.

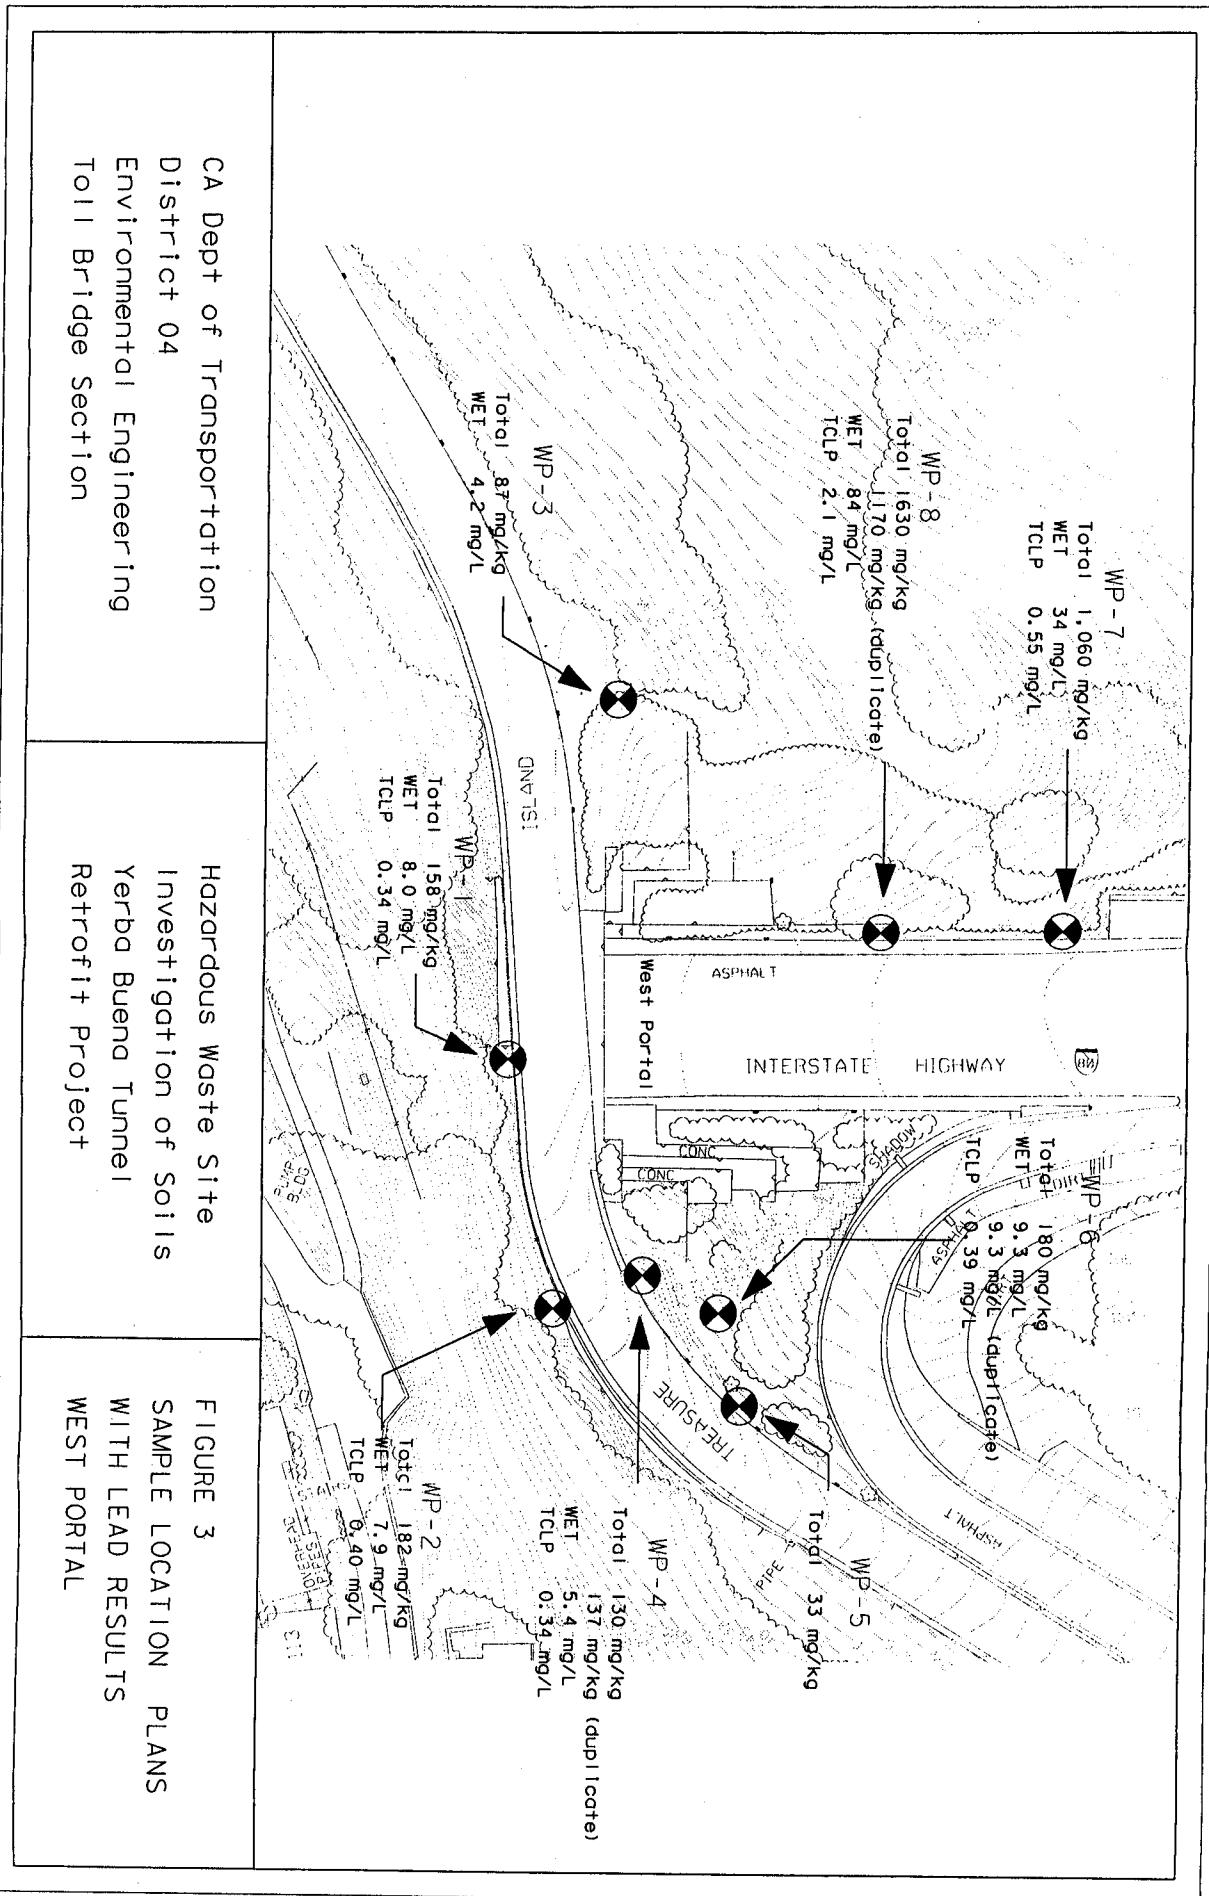
FIGURE 3

**SAMPLE LOCATION PLANS WITH LEAD RESULTS
WEST PORTAL**

SAMPLE LOCATION PLANS
WITH LEAD RESULTS

Fourteen surficial soil samples were collected on November 23, 1998. Eight surficial soil samples were collected above and adjacent to the west portal (WP1 through WP8) and six surficial soil samples were collected above and adjacent to the east portal (EP1 through EP6). The approximate sampling locations for the west portal and the east portal are depicted on Figure 3 and Figure 4 respectively.

Surficial soil samples were collected at WP-1 and WP-2 to characterize residues and debris resulting from drilling of anchorage holes for the center faced wedge-shaped feature located in the sandstone rock above the right side of the west portal centerline. Seismic retrofit at this location has since been removed from the scope of work for this project. Surficial soil samples were also collected at WP-3, WP-7, and WP-8 to characterize residues and debris resulting from drilling of anchorage holes for the siltstone outcrops at the right shoulder of the portal. Due to the severe slope at this outcrop, samples were collected at the top (WP-3) and toe (WP-7 and WP-8) of the slope. Seismic retrofit at this location has also been removed from the scope of work for this project. Surficial soil samples were collected at WP-3 and WP-4 to characterize soils to be excavated during installation of stiffener beams to the portal wall. Surficial soil samples were collected at WP-4, WP-5, and WP-6 to characterize residues and debris resulting from drilling of anchorage holes for the rock outcrop at the left shoulder of the portal.

Seven soil samples exhibited total lead concentrations greater than ten times the STLC value. These samples were subsequently analyzed for soluble lead via the WET method. Six of these samples exhibited soluble lead concentrations greater than the STLC of 5.0 mg/L. These six soil samples were further analyzed for soluble lead via the TCLP and exhibited soluble lead concentrations less than the regulatory threshold of 5.0 mg/L. Other total Title 22 metals were not detected at concentrations greater than the respective TTLC values or greater than ten times the respective STLC values. The summary of the analytical laboratory results is presented in Table 1.

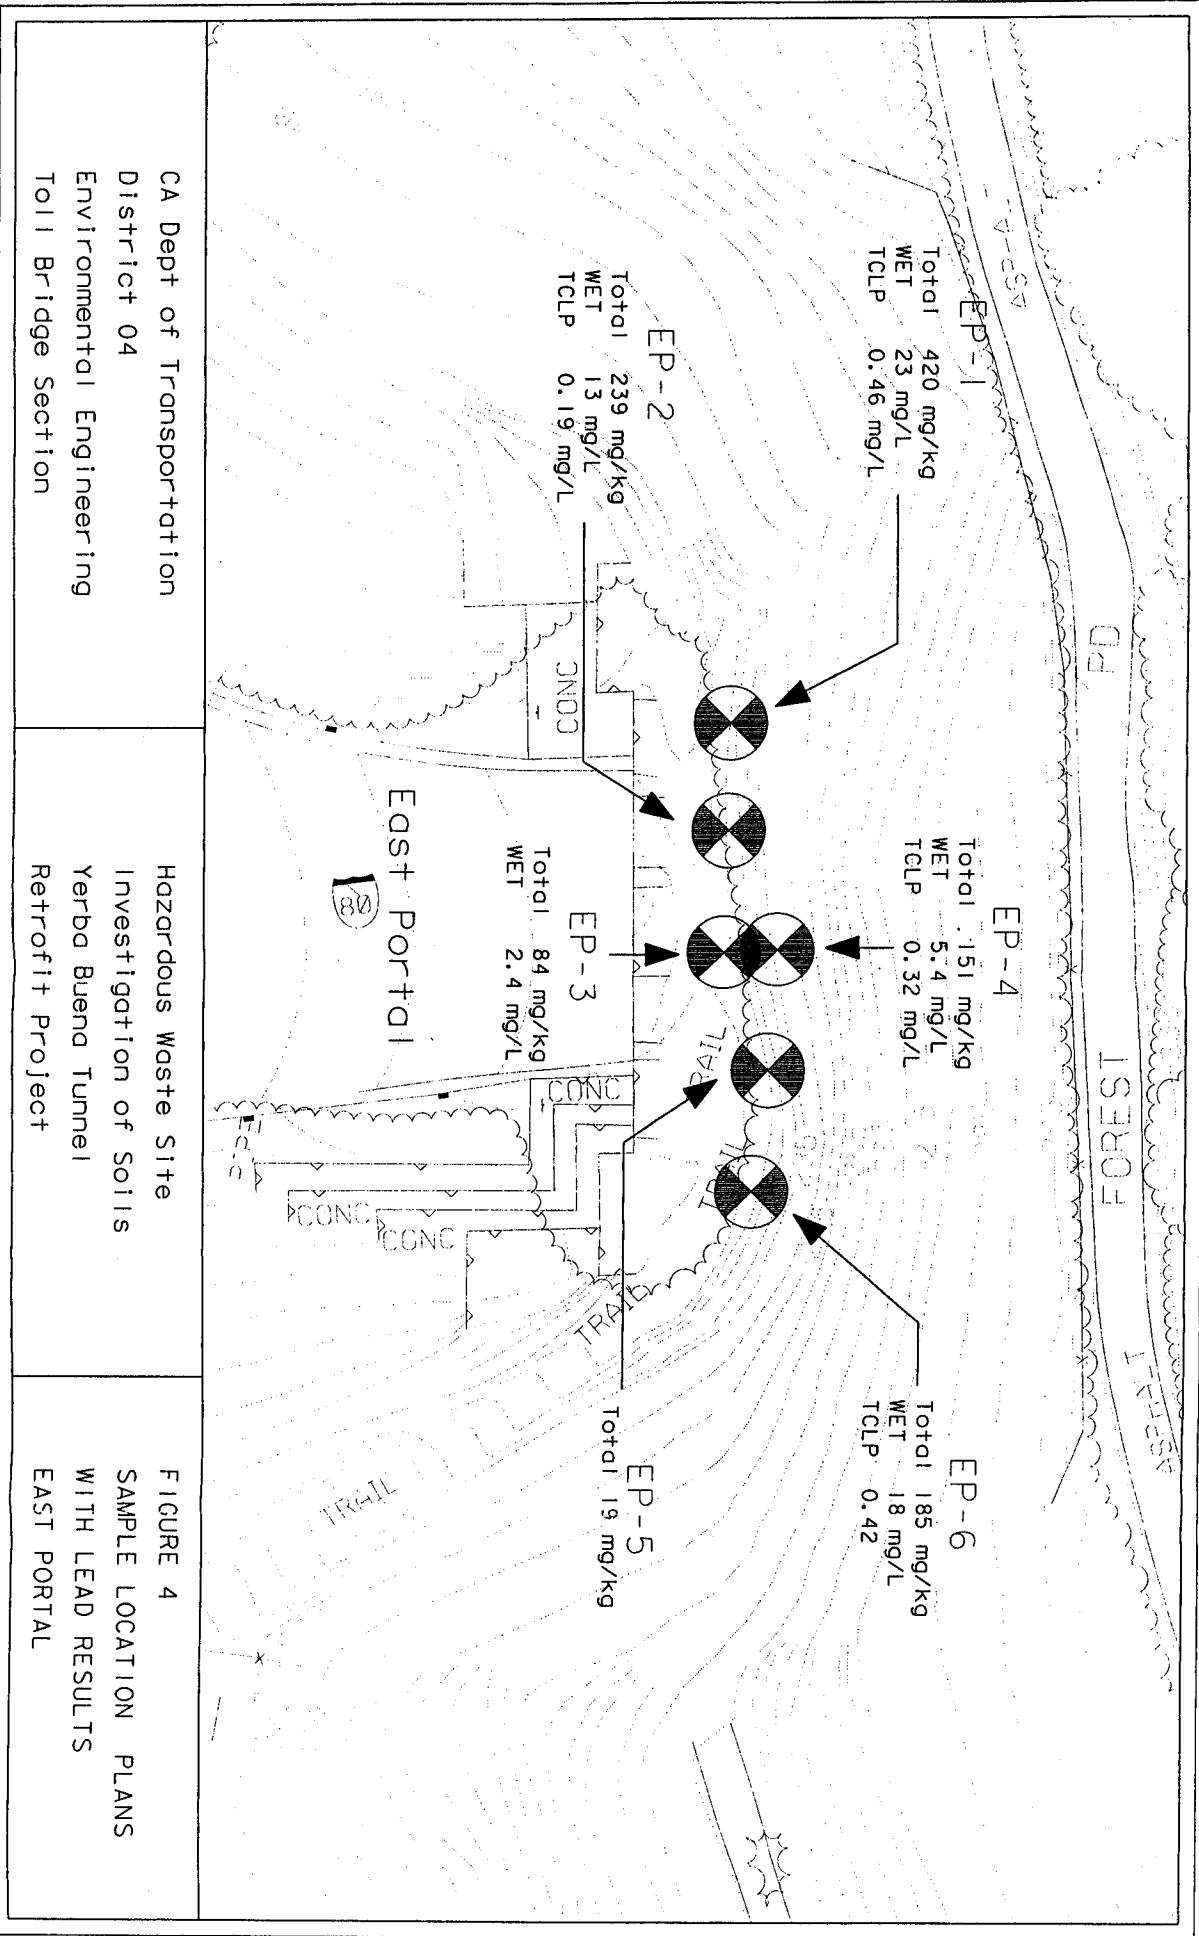
FIGURE 4

**SAMPLE LOCATION PLANS WITH LEAD RESULTS
EAST PORTAL**

Surficial soil samples were collected at EP-1, EP-2, EP-3, EP-4, EP-5, and EP-6 to characterize soils to be excavated during installation of stiffener beams for the portal wall. The installation of tieback anchors at the portal retaining walls will generate residue and debris, thus soil samples

Five soil samples exhibited total lead concentrations greater than ten times the STLC value. These samples were subsequently analyzed for soluble lead via the WET method. Four of these samples exhibited soluble lead concentrations greater than the STLC of 5.0 mg/L. These four soil samples were further analyzed for soluble lead via the TCLP and exhibited soluble lead concentrations less than the regulatory threshold of 5.0 mg/L. Other total Title 22 metals were not detected at concentrations greater than the respective TTLC values or greater than ten times the respective STLC values. The summary of the analytical laboratory results is presented in Table 2.
